# NATIONAL TRANSPORTATION SAFETY BOARD

PB98-916611

## TRANSPORTATION SAFETY RECOMMENDATIONS

ADOPTED DURING THE MONTH  
OF NOVEMBER, 1998

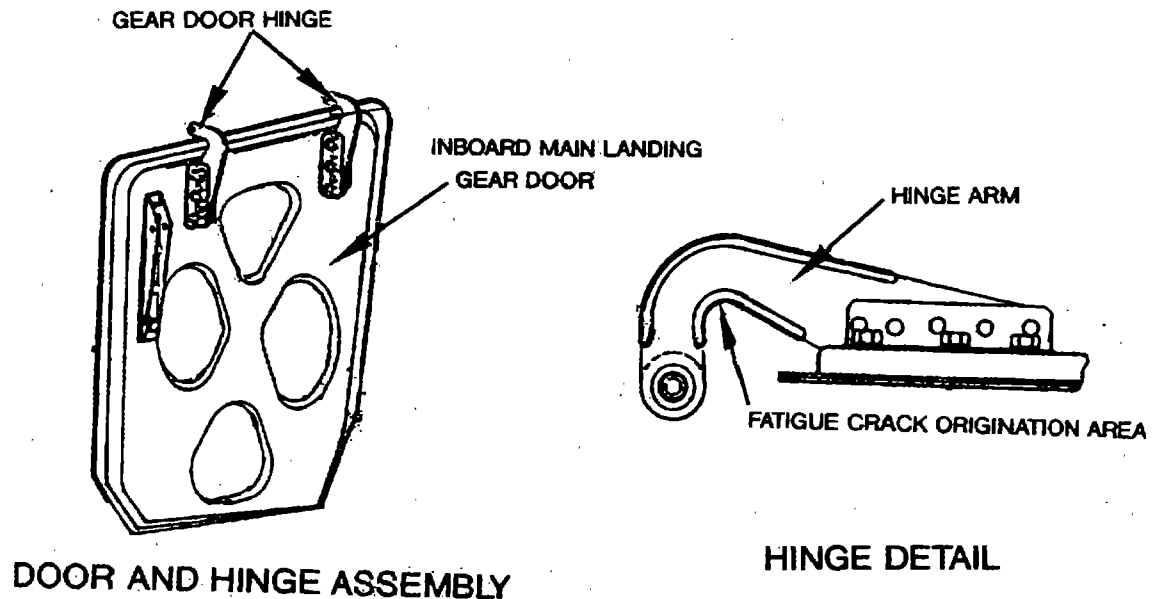
**Figure 1. Piper PA-31 Main Landing Gear Door Assembly**

arm (see figure 1). The arm is subjected to cyclic loading during service, and the forging flash is a high-stress region of the hinge.

In 1980, following several incidents of fatigue cracks in the original hinge, Piper Aircraft Corporation (now New Piper Aircraft, Inc.) issued Service Bulletin (SB) 682, which recommends inspection of the PA-31 MLG inboard door hinge assemblies and hinge attachment angles for cracks within the first 100 hours of operation or during the next scheduled inspection, whichever occurs first, and every 100 hours thereafter unless/until an acceptable replacement part is installed. The SB recommends that all cracked door hinges be replaced with the improved P/N 47529-32 hinge assemblies before further flight. Upon installation of the improved hinge assembly, repetitive inspection of the hinge assembly is not required. On December 19, 1980, the Federal Aviation Administration (FAA) issued Airworthiness Directive 80-26-05, mandating the actions specified in this SB.

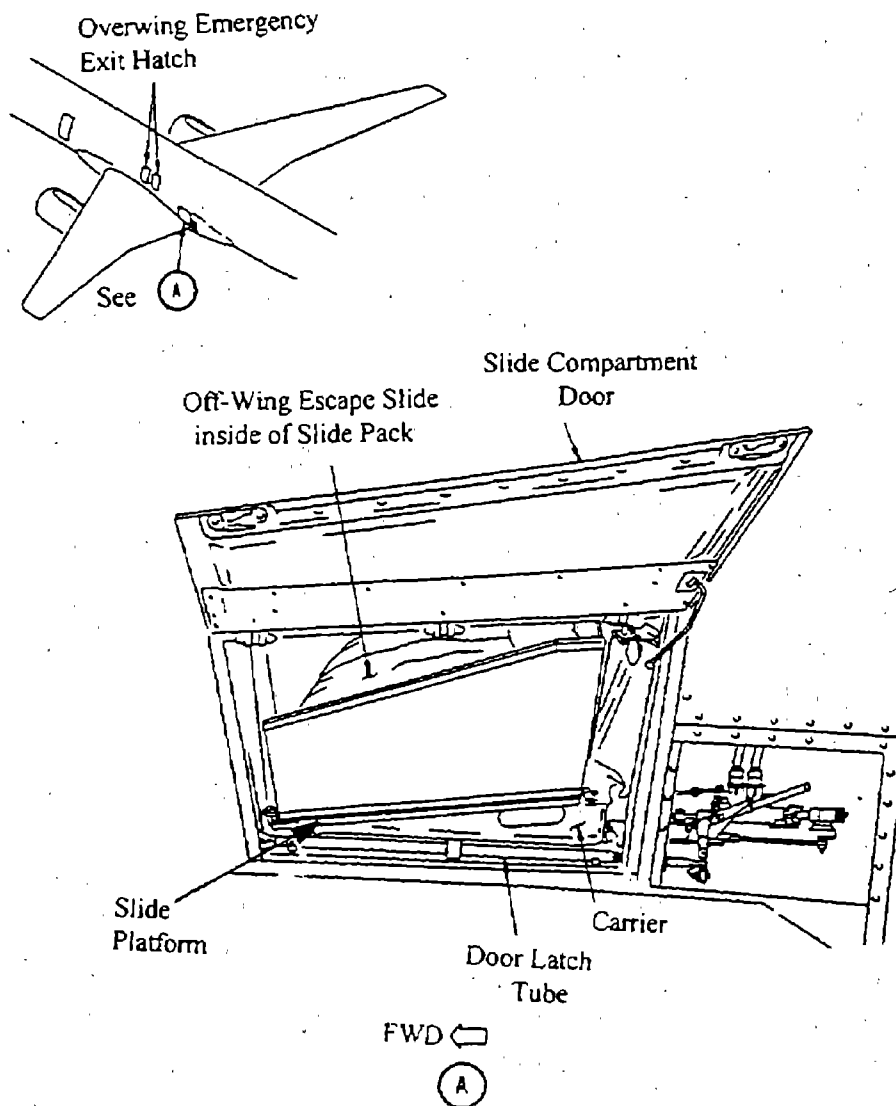
Figure 1.—B-757 Off-Wing Escape Slide Assembly

down position, stating that "it took several attempts to move the actuator handle to the latched position." The mechanics stated that after the door was latched one mechanic ran his finger around the door to ensure it was closed, and then both mechanics checked the EICAS in the cockpit to ensure that the door was closed. One of the two mechanics said that he had received instructions on how to replace the slide about 4 or 5 years ago during a 2-week B-757 initial maintenance training class that provided instructions on all B-757 systems. The other mechanic had not yet received training on the B-757 off-wing escape slide replacement during his 3 months of employment at Delta.
